### FAST FACTS

## Conveyor belt replacement

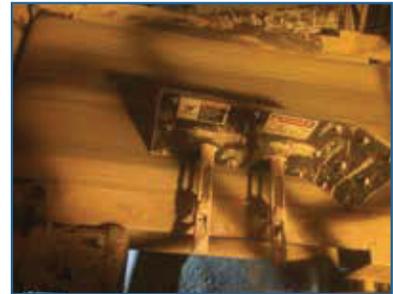
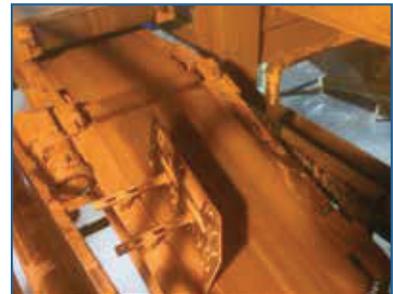
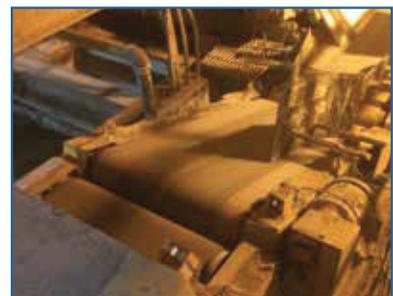
Bags traveling on a conveyor belt in the plant were being torn open when pushed by a mechanized arm. The conveyor belt was gripping the bags too firmly, causing some of them to rip upon contact with the mechanical arm.

ERIKS examined the belt with another equipment manufacturer and determined that the incorrect belt was being used for this process. It was recommended that a longitudinal groove belt replace the rough top belt that was currently in use.

Since installation of the new belt was completed, the plant's production has increased by one pallet per hour and there are no longer any issues with bags being ripped open. By eliminating this problem and increasing production, Lewis-Goetz was able to save the customer over \$1 million annually.

**By installing a different type of belt,  
ERIKS increased the plant's  
production and reduced cleanup costs.  
This has saved the company over  
\$1 million annually.**
